# McMinnville Oregon Chooses Infrastructure Repair Systems for Lateral and Mainline Point Repairs

By: Ron Dick *Sales Manager @ Infrastructure Structure Repair Systems Inc.*  
April 14, 2012

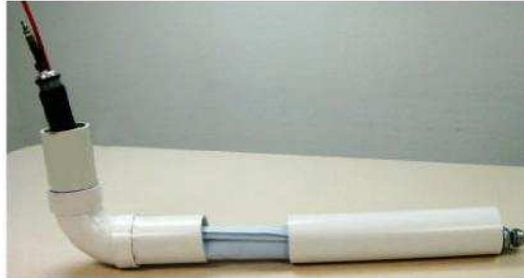
At the clean-out just outside the home on Oregon Street, the crew inserted a push camera down the 4-inch lateral pipe locating the damaged area just a few feet from the main. The damage was accessed and the liner length is selected. It should cover the damage and 1 foot on each side.

IRSI Lateral Point Repair System using a specially designed carrier that allows it to navigate the 90-degree bend found in most lateral services.

this lateral repair, the crew will use a specially designed carrier that allows the IRSI Point Repair the ability to negotiate the 90-degree bend found in most lateral services.

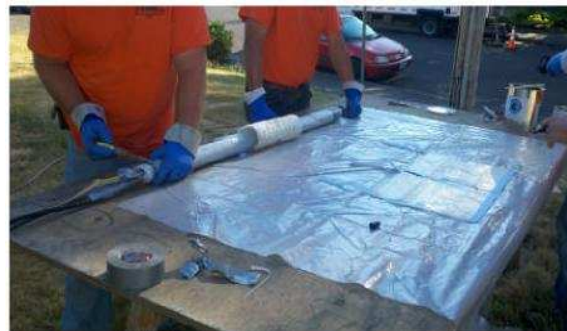
McMinnville crew preparing the carrier and liner for insertion into line.

Once the distance to the damaged area was determined and the line cleaned, the crew began the simple process of wet out, wrapping the carrier and insertion. The cure-out phase of the

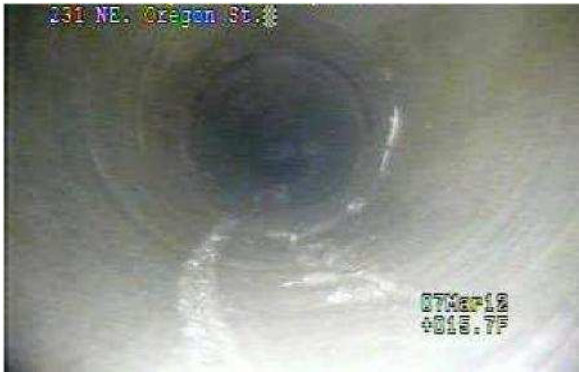
It is at this time the push camera was re-inserted into the line and an after shot was taken. This was confirmation that the repair was correctly installed, the break and leak permanently repaired. When asked, Jones explained that by using the IRSI trenchless mainline and lateral repair system “the city saves a significant amount of money with little or no disruption of service.”

Camera shot of repaired line.

temperatures.) After the Oregon Street lateral repair was cured, the carrier was deflated and removed from the line.
